6 PEMBROKE BAY

6.1 Introduction

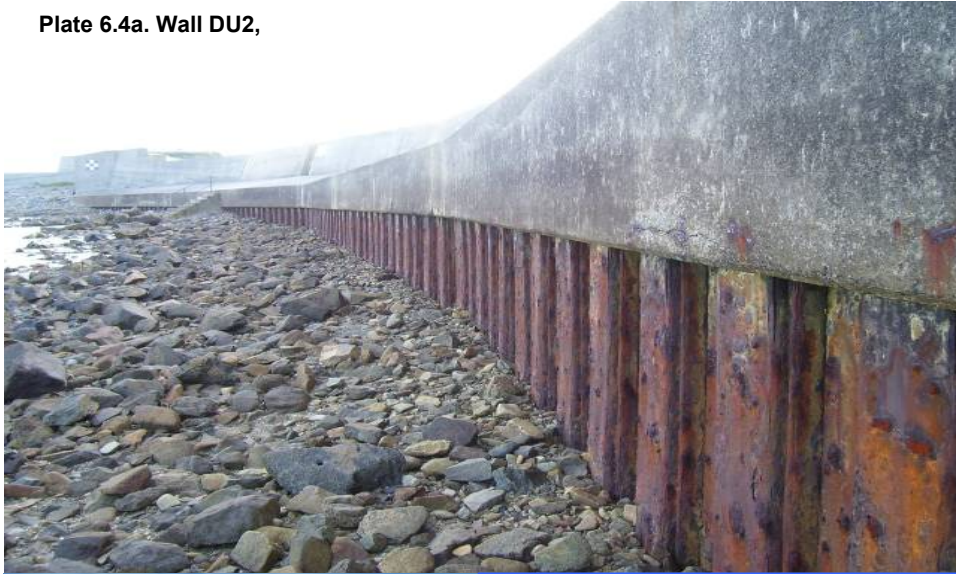
Plate 6.4a. Wall DU2,

The main western wall comprises a mass concrete back wall, with a front berm constructed over a steel sheet pile foundation at the toe of the wall. These sheet piles are exposed to a height of approximately 1m to 1.5m over much of the length of the wall and, although the piles appear not to be corroded through, there is quite severe corrosion (Plate 6.4a). The frontage has a generally low foreshore comprised of small rocks and boulders, devoid of sand apart from at the southern end. There is some evidence that this foreshore has been gradually eroding, with stones bonded to the sheet piles with rust at a level some 150mm above the current level of the general foreshore. The wall has a typical level of 7.2mLOD with the ground levels behind the wall some 1m lower.

Continued loss of beach material (and an associated reduction in the beach level) together with deterioration of the sheet piles is placing the structure at risk. A probable failure mechanism would be the loss of fill material beneath the deck of the front berm with failure initially of this element of the wall. This is likely to cause instability in the main mass concrete wall behind. Failure may be expected over the next 10 to 20 years.

On the western wall, in order to secure this structure over the medium term there will be a need to reduce scour and to address the deterioration of the toe piles. The critical element at present is the sheet piles. Under this option the protection would be a rock toe extending up to the concrete apron. This would need to be improved and reinforced with sea level rise, such that the wall would be faced eventually with a larger rock revetment over its full length.

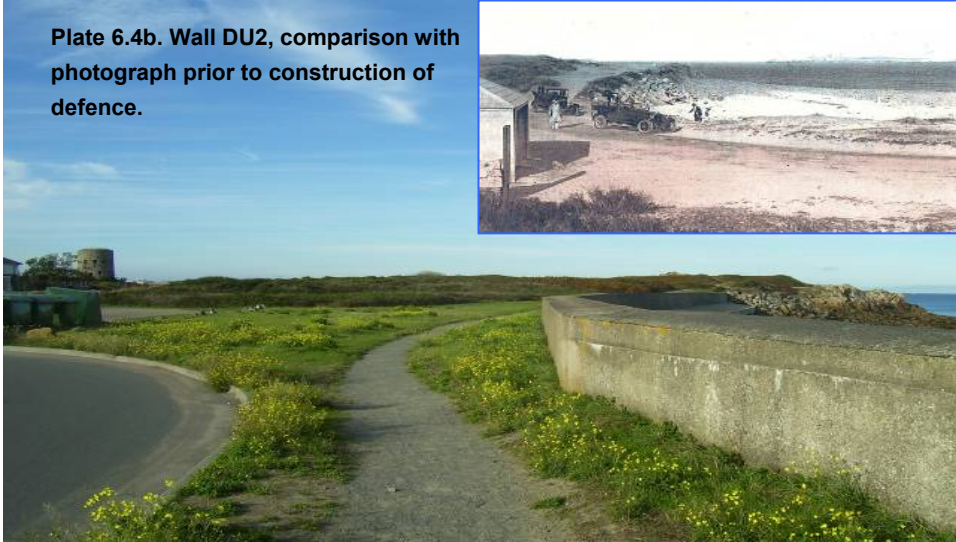
Plate 6.4b. Wall DU2, comparison with photograph prior to construction of defence.

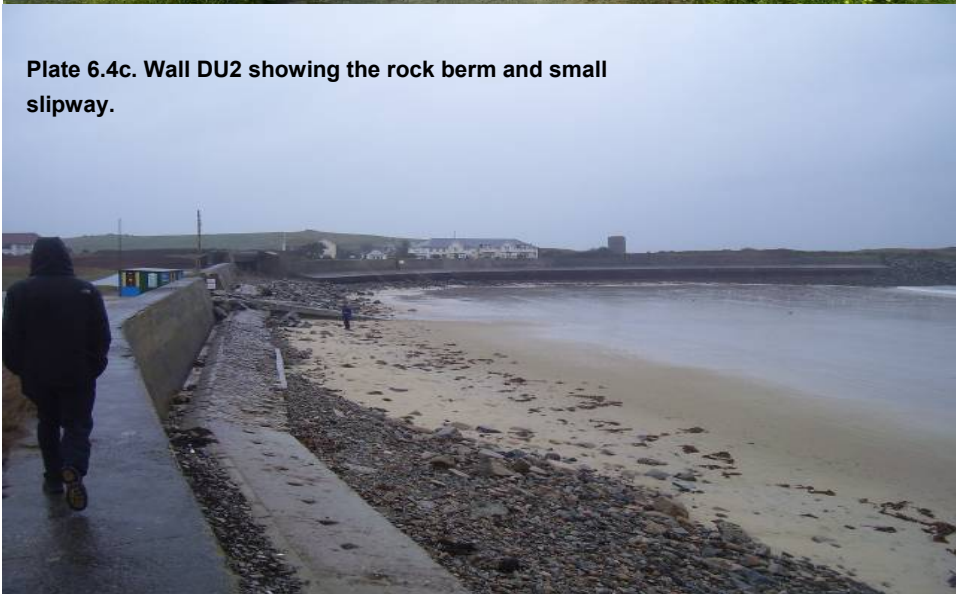
Plate 6.4c. Wall DU2 showing the rock berm and small slipway.

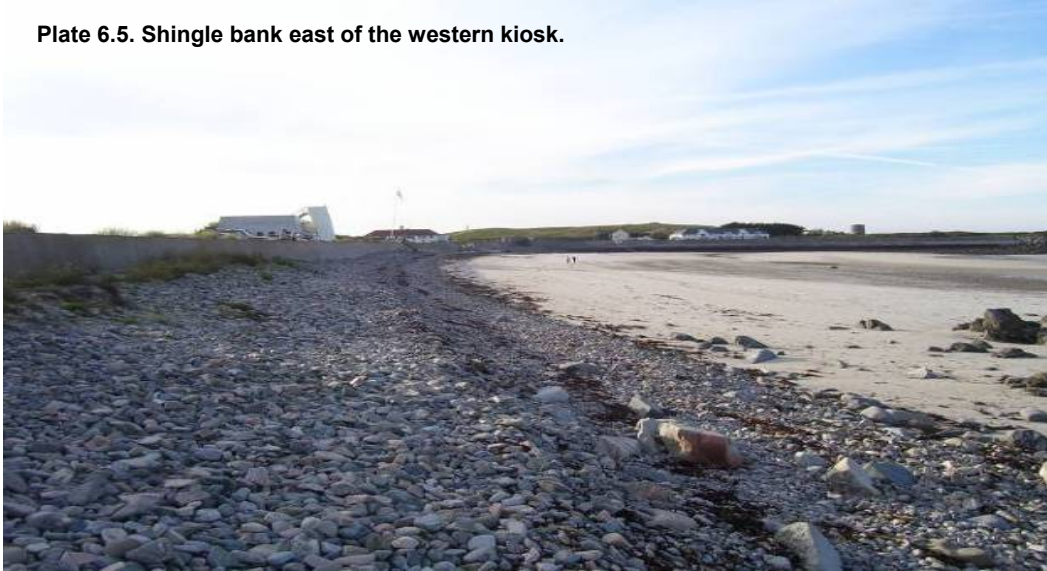
Plate 6.5. Shingle bank east of the western kiosk.

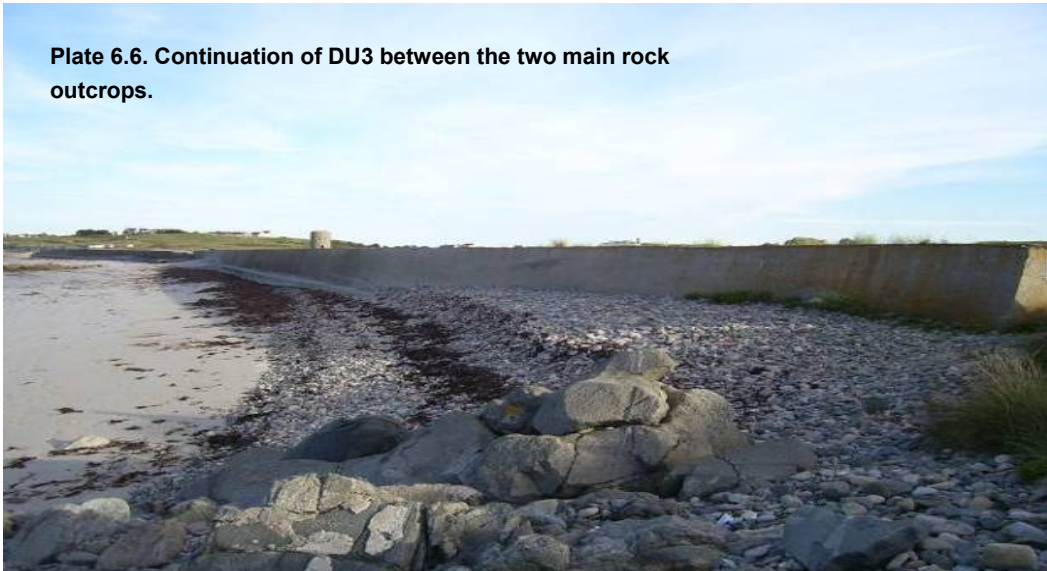
Plate 6.6. Continuation of DU3 between the two main rock outcrops.

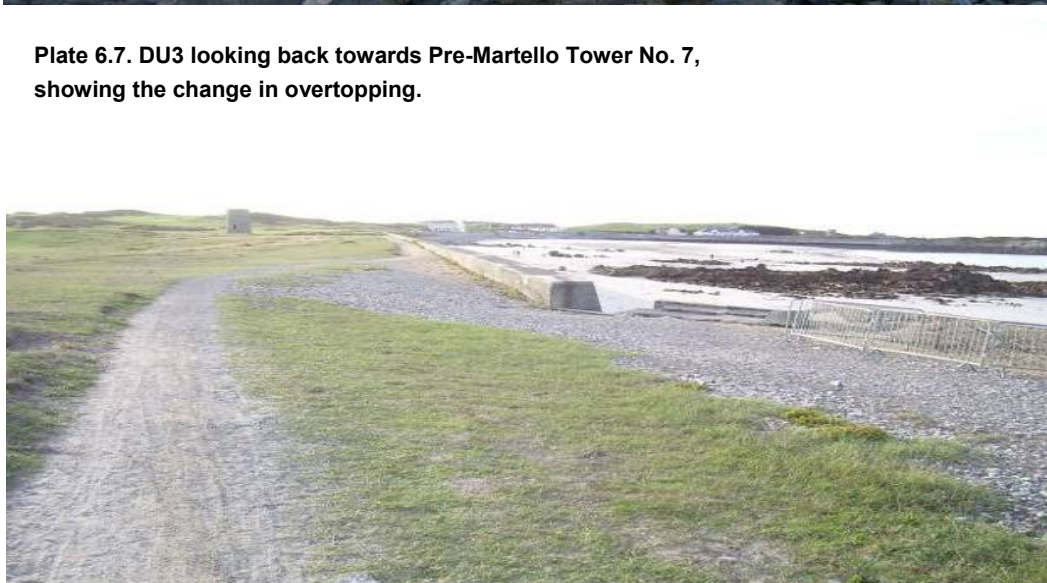
Plate 6.7. DU3 looking back towards Pre-Martello Tower No. 7, showing the change in overtopping.

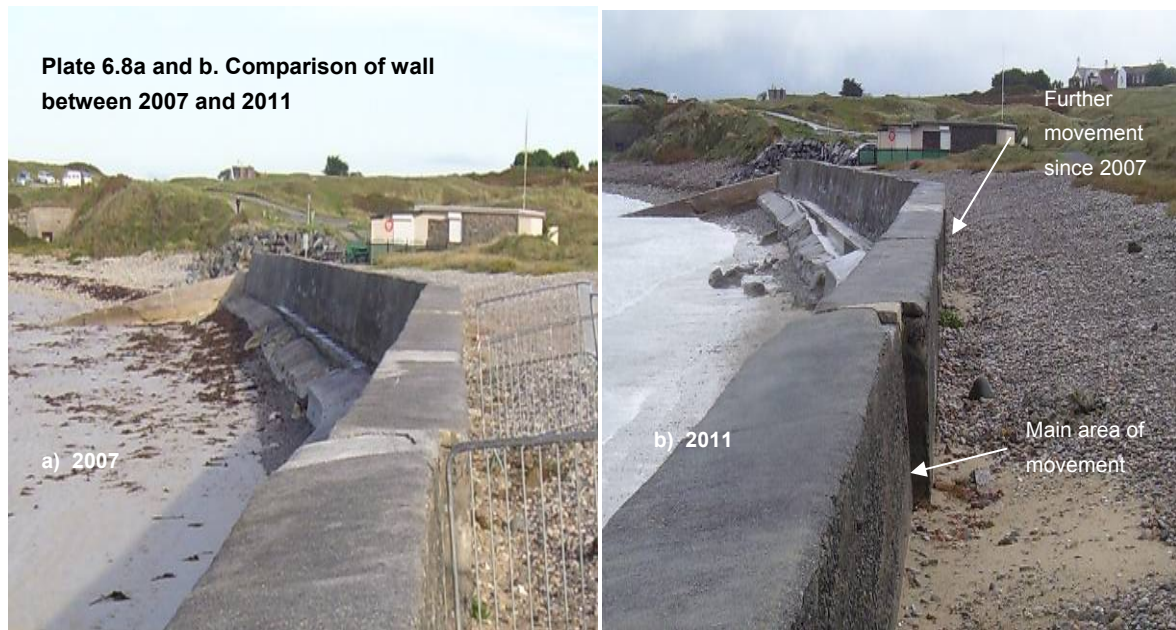
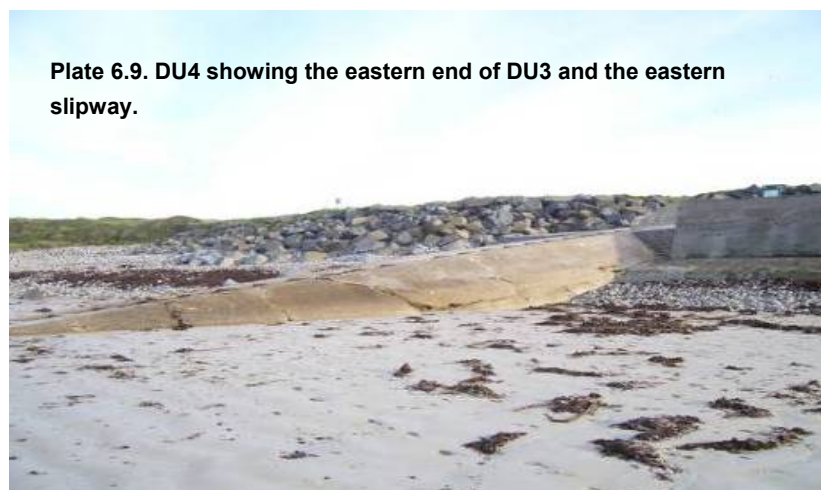
This change in alignment also marks a major change in the condition of the wall, with lower beach levels and a severe problem of undermining of the heavy toe. The general condition of the wall to the west is fair, with the main problems occurring at the far western end by the slipway. This section of wall has a typical residual life of some 10 to 20 years with increased maintenance at the western end. To the east of the transition point shown in Plate 6.8, the condition of the wall is poor, with very obvious movement of the wall and regular damage occurring to the toe.

Plate 6.8 shows the variation in the wall over the last four years, despite work to reinforce the toe.

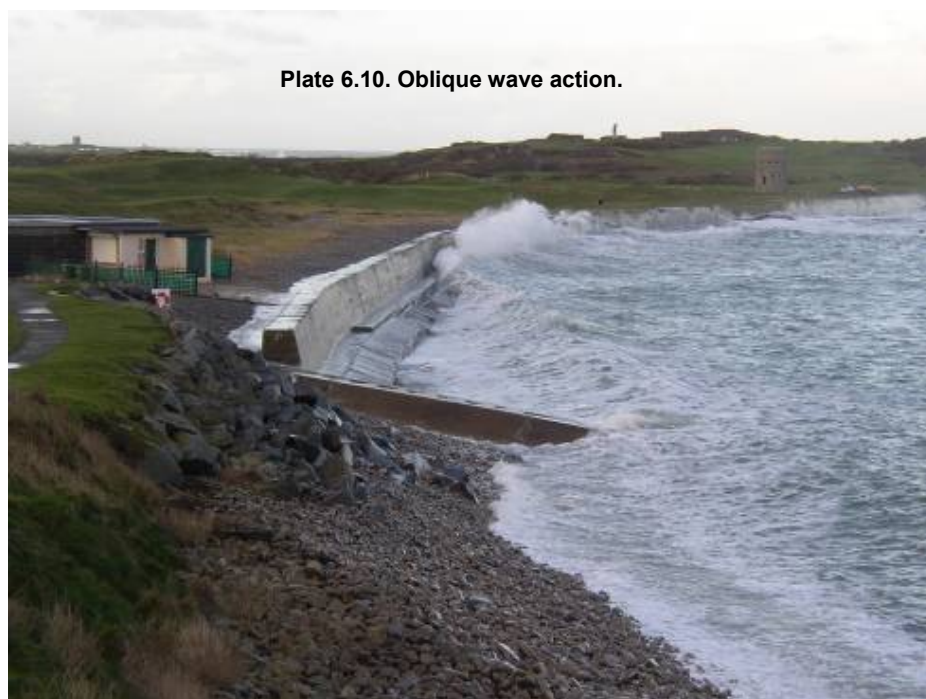
The greatest obliquity is shown to be at the eastern end of the defence, in front of the kiosk. This is consistent with observations (Plate 6.10). There is a similar interaction at the far western end, with waves potentially forming a bore or Mach Stem effect along DU2 on a north north-east storm and more generally waves working at a steep angle into the corner between DU2 and DU3 by the western slipway. The implications of this wave climate on beach and defence behaviour is discussed below.

Plate 6.10. Oblique wave action.

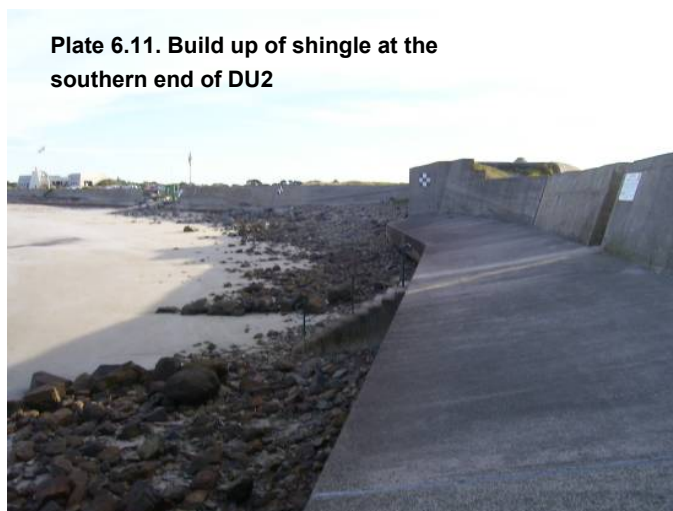
Plate 6.11. Build up of shingle at the southern end of DU2

deposit stone into the corner and this is seen in the relatively high, very coarse, shingle slope. While there is movement of sand into the area, the generally higher energy wave action tends not to allow this sediment to be retained. The area is, under the more westerly wave conditions, still relatively low energy, but wave heights increase as one progresses to the east.
