OBSERVATION REPORT

16, Fountain Street St Peter Port

Re: - 16, Fountain Street, St Peter Port

We confirm your instructions to undertake a formal written report as to the structural condition and recommendations of the shop front head beam at the above.

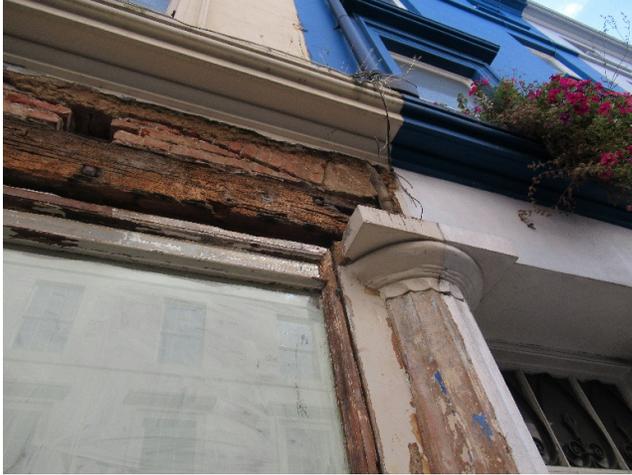
The head beam was originally carrying a smaller amount of masonry up to the brick arch, the arch has now failed externally due to the rot in the existing timber beams. The timber beams are a pair of 150 x 300 timbers bolted together.

Existing beams totally rotted on the right-hand side, head and also rotted at the central support.

We also investigated the internal section of the double beam at the right-hand side and this was also found to be in very badly rotted state at the bearing end.

This rotten beam now carries the entire weight of the front of the premises, this being 3 floors of masonry, which is now due to the brick arch failure.

This timber beam is rotted and needs immediate removal and replacement.

It is envisaged that the new beam will be treated steel and then re-rendered to look exactly like the original opening.
