6 PEMBROKE BAY

6.1 Introduction

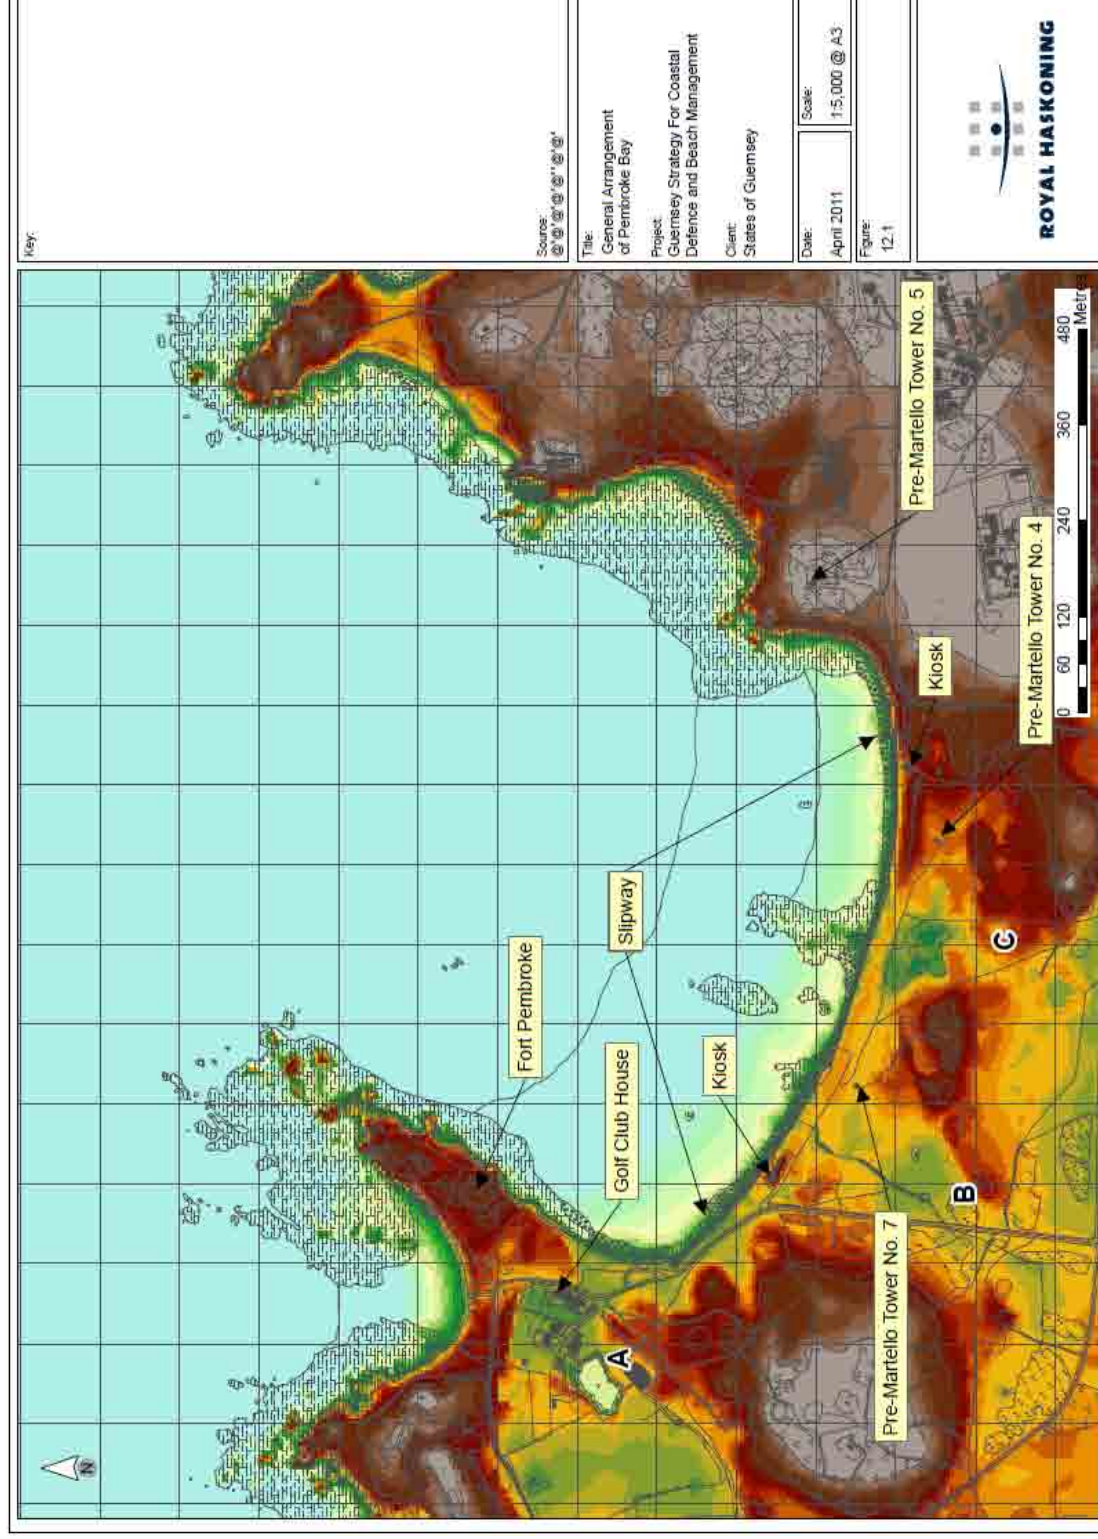
Figure 6.2 General Arrangement of Pembroke Bay showing land features overlying a relief map of the Area.

There are three areas of relatively low lying land running as valleys back from Pembroke Bay, shown on Figure 6.2 as locations “A”, “B” and “C”.

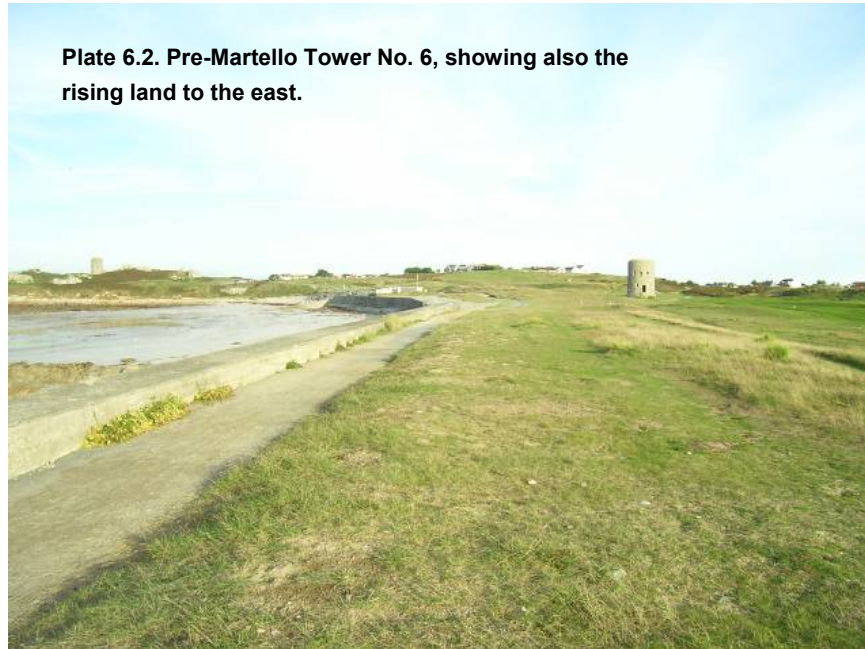
The Golf Club house and various properties are located within valley “A” and the pre-Martello Tower No. 7 lies to the edge of valley “B”. The pre-Martello Tower No. 6 lies to the east of valley “C” (Plate 6.2), with high ground continuing quite close to the shoreline through to pre-Martello Tower No. 5 and the start of the eastern headland.

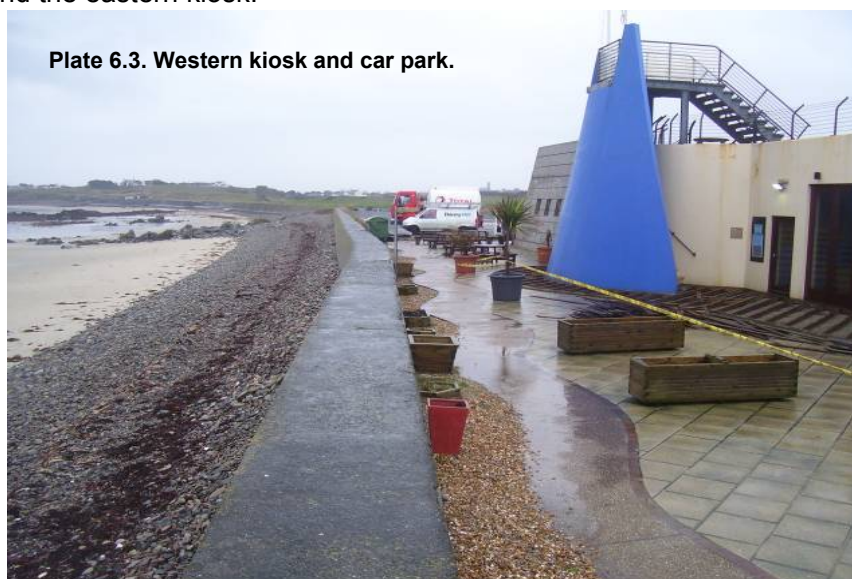
There are two kiosks situated behind the defences. The western one, which has been developed as a restaurant, is located on the relatively low lying land between locations “A” and “B” (Plate 6.3). The eastern kiosk is founded on the higher ground. Both locations have car park facilities, the main car park being at the western end. The main access roads to the Bay run along the western valley “B” and, in the east over the high ground behind the eastern kiosk.

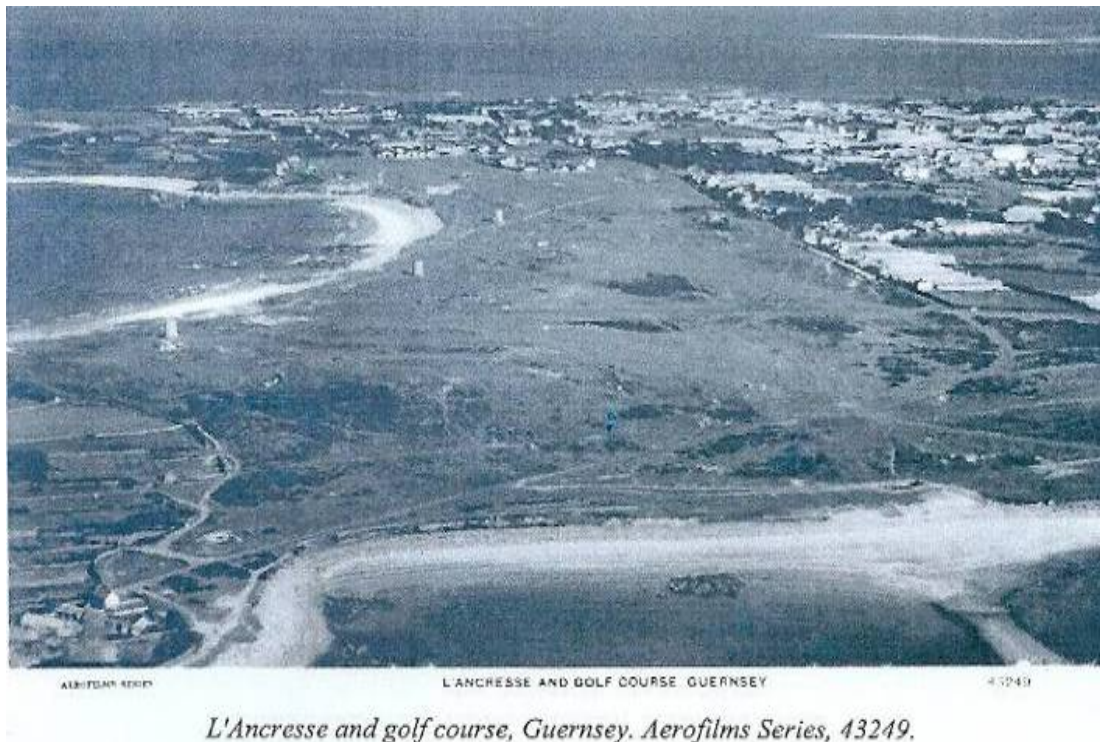
Figure 6.3 Pembroke Bay 1930

Figure 6.3 shows an air photograph of the bay showing the back of the Bay in the 1930s. It shows a wide sand shingle beach at the eastern end in relation to the position of the pre-Martello Towers.

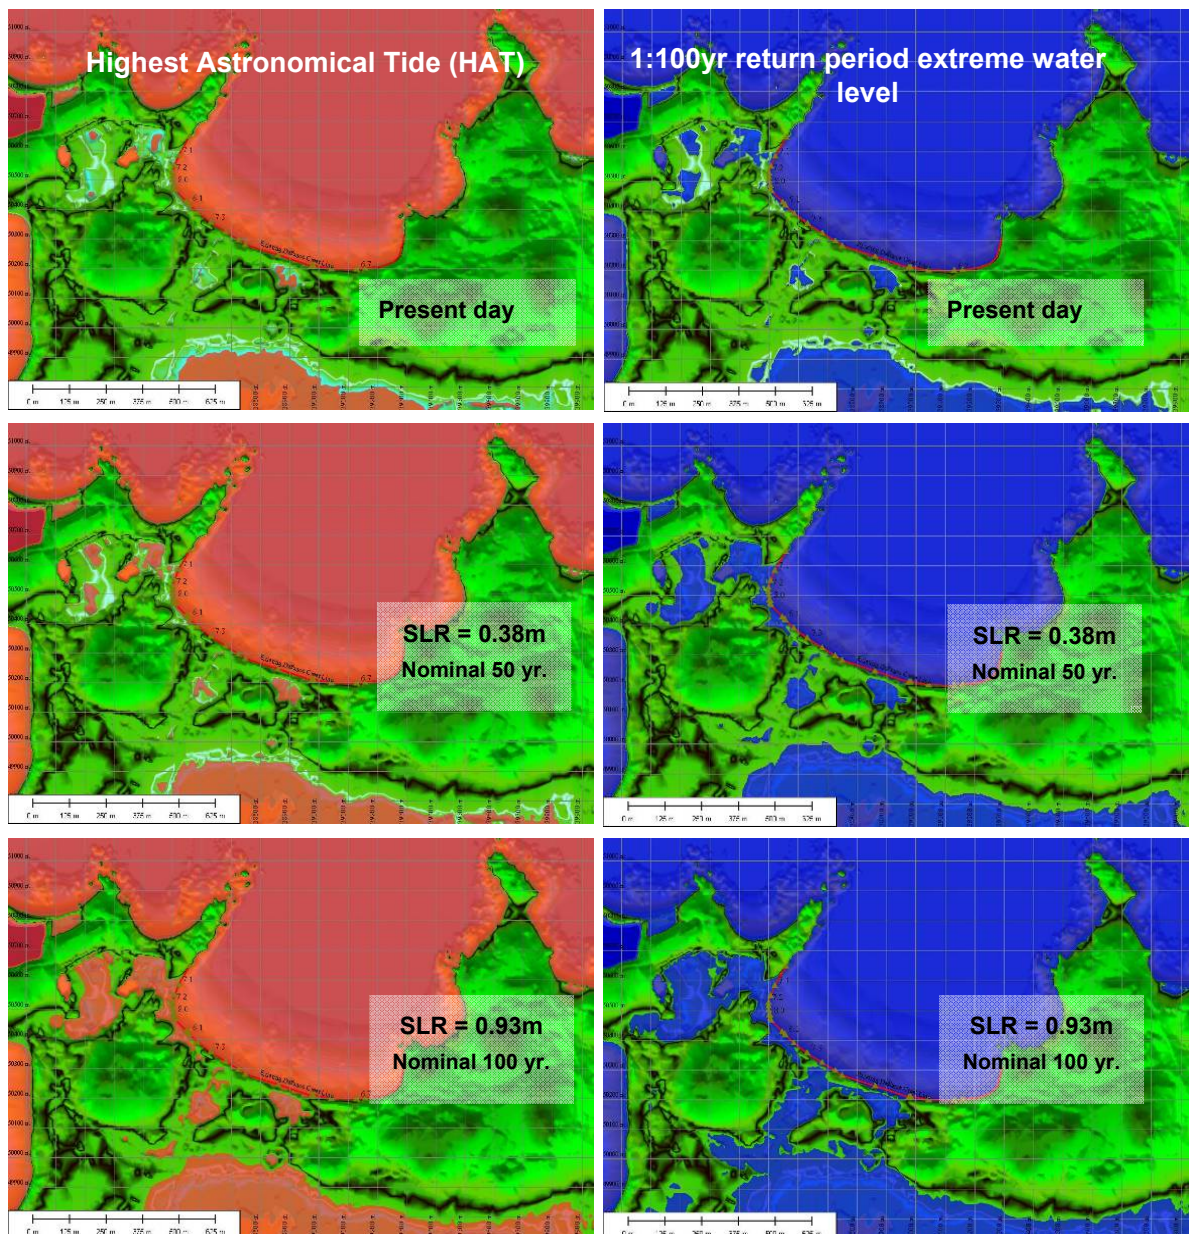
Figure 6.6. Broad scale Flood risk with sea level rise (SLR).

Although there are areas of land in the hinterland below HAT (potential flood areas shown in red), at present the land levels directly to the rear of the bay are such that

flooding to the hinterland is unlikely to occur. There is slightly greater risk along the western frontage for the 1:100 year water level, with the sea wall providing the flood defence. However, even here the flood risk is quite local. Overtopping is unlikely to generate sufficient water to cause significant flooding to the local hinterland even along the western frontage.

With 0.38m of sea level rise, for HAT, there would be increased flood risk, similar to that of the 1:100 year extreme at present. In the case of the 1:100 year extreme level in 50 years time, the flood risk to the western frontage increases such that there would be more extensive flooding along the western frontage in the absence of the western walls (DU2 and the western section of DU3). Overtopping is likely to increase and under extreme events this may cause local flooding in the area of the Golf Club house. There might also be flooding to the low lying area, locally to the area referred to as valley "C" in Figure 6.2. The area of the main car park is above the water level but would be subject to increased overtopping. Overtopping would also increase along the eastern section of the bay. This would be due largely to the interaction between the wall and waves.

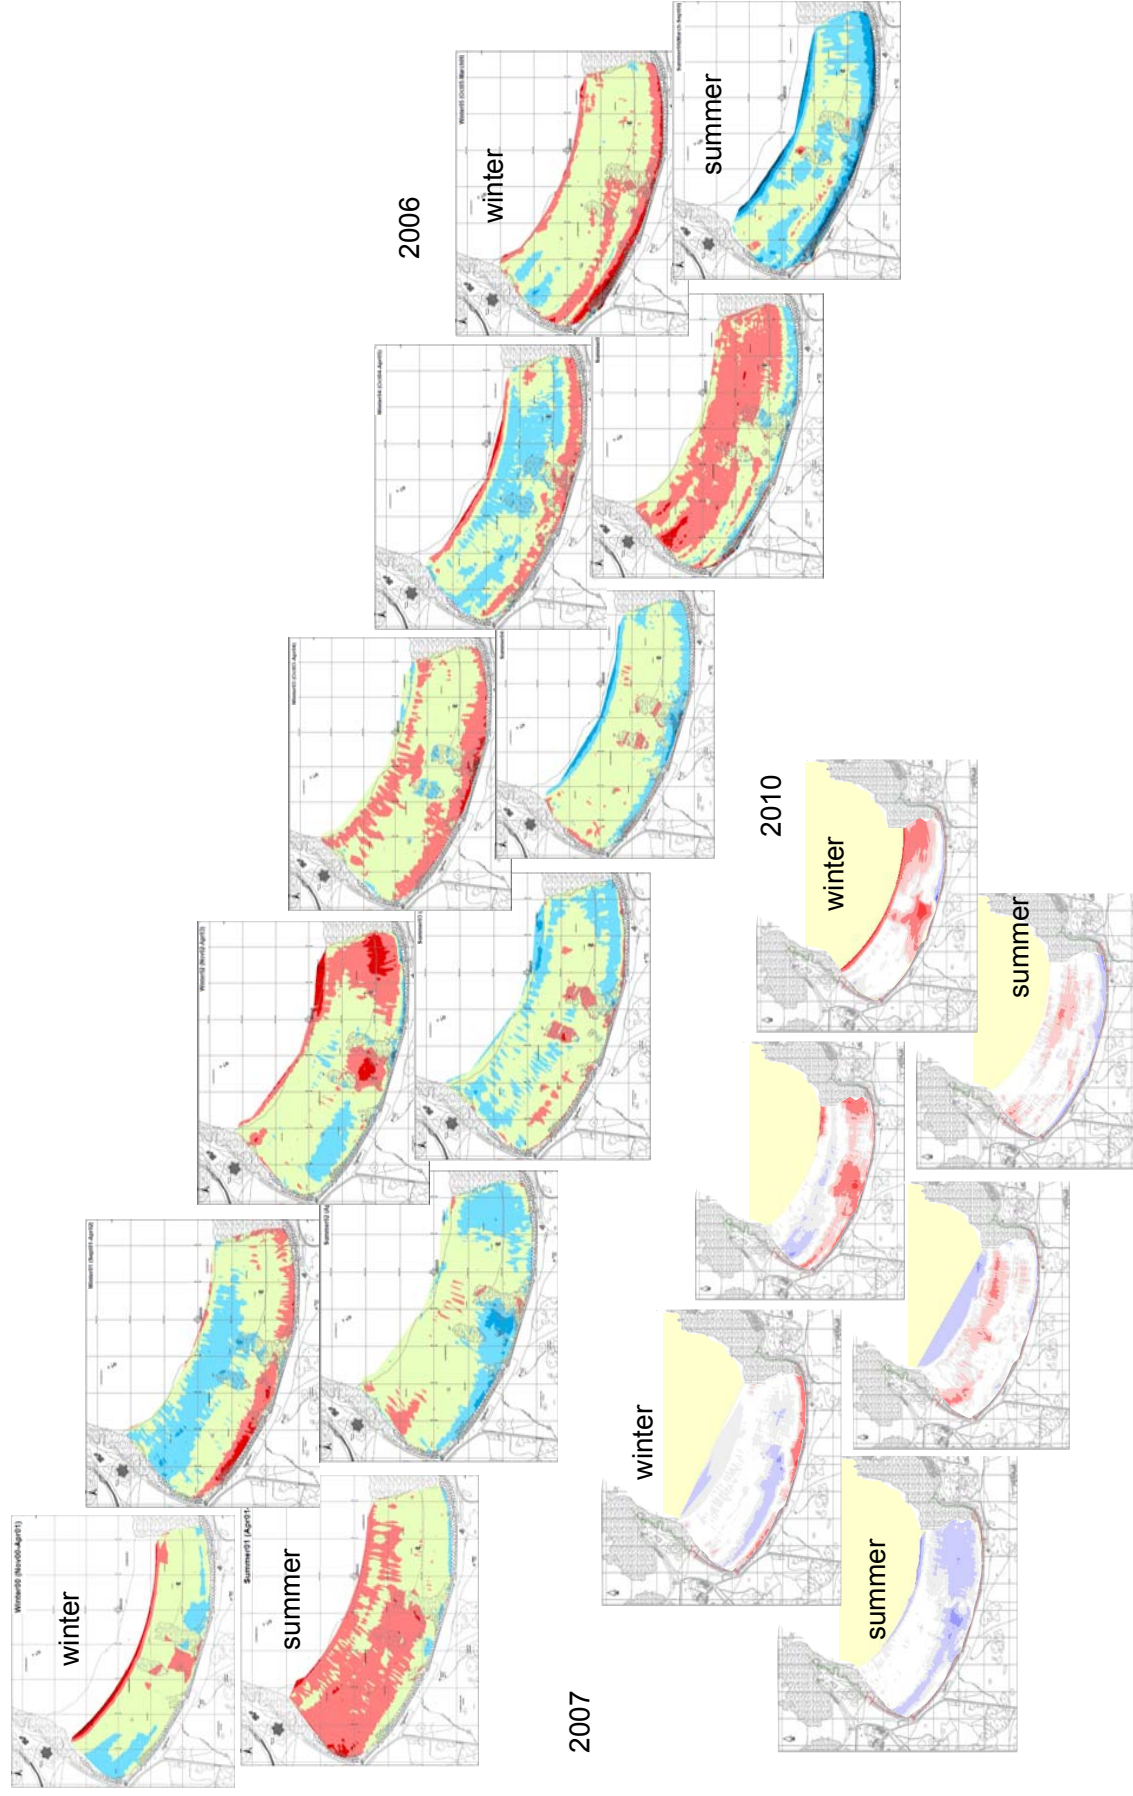
Figure 6.7. Change in beach levels

The broad pattern of change is for erosion to the back of the beach (shown in red) and deposition lower down the beach (shown in blue). During the summer periods the typical behaviour is for sediment deposition against the back of the beach and lowering of the foreshore lower down the beach. In effect, sediment is being driven up the beach during the summer, during periods when wave conditions tend to be lower and when the process is likely to be driven by the regular longer period swell waves driving across the beach. During the winter, when there is a greater frequency of shorter period, higher waves; the waves impact on the back defence, drawing sediment down the beach.

During the winter of 2010, there was severe erosion of the lower beach, particularly to the eastern end, with little benefit gained at the back shore.

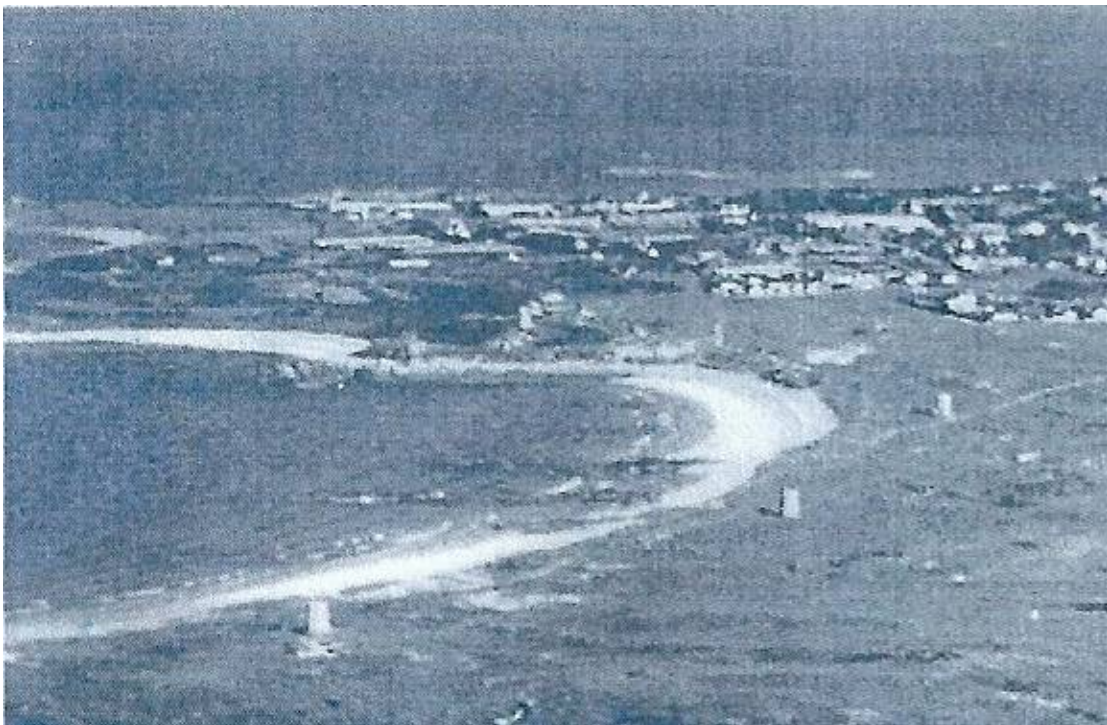
Figure 6.8. Pembroke Bay 1930s.

This figure shows a deeper indent to the bay at the eastern end, backed by a solid shingle beach and ridge behind. In the centre of the bay, the influence of the rock outcrop is clearly seen holding the bay slightly forward but with a steeper back cliff behind and by the way in which the rock in the centre of the bay allows the development of a beach and dune ridge over the western side of the bay. Some of the features local to the shore have clearly changed. However based on this photograph together with a historic map from 1938 an approximation can be made of the alignment of the backshore prior to the construction of defences. This is shown in Figure 6.9. The historic map is shown as an insert in the Figure. There appears to have been some form of

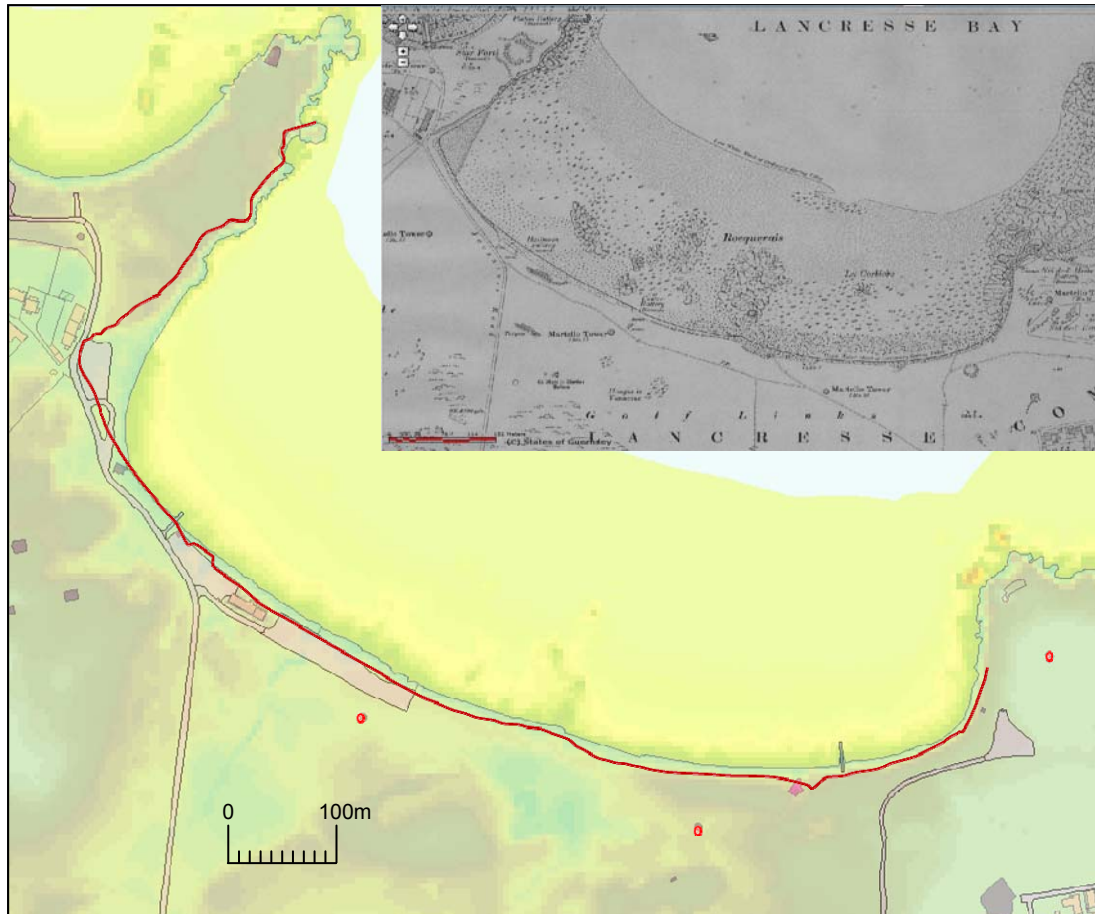
Figure 6.9. Initial Estimate of Erosion based on historic photograph.

defence even at this time to the east of the bay in front of a building in this area. This provides a typical baseline for additional analysis of potential erosion that might occur now in the absence of defences in the area.
